DAMAGE TO THE HISTORIC TOWN OF STAUFEN (GERMANY) CAUSED BY GEOTHERMAL DRILLINGS THROUGH ANHYDRITE-BEARING FORMATIONS

Ingo SASS¹ & Ulrich BURBAUM²

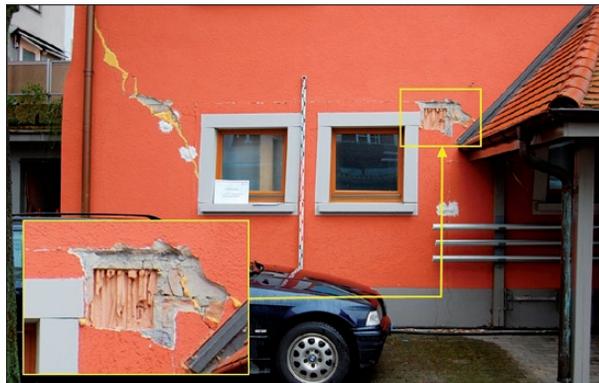
Fig. 2: Uplift cracks in building Kirchstraße, inner courtyard, distance to the well field approx. 20 m to the east. Destruction of the supporting masonry, March 2009 (Photo: U. Burbaum).

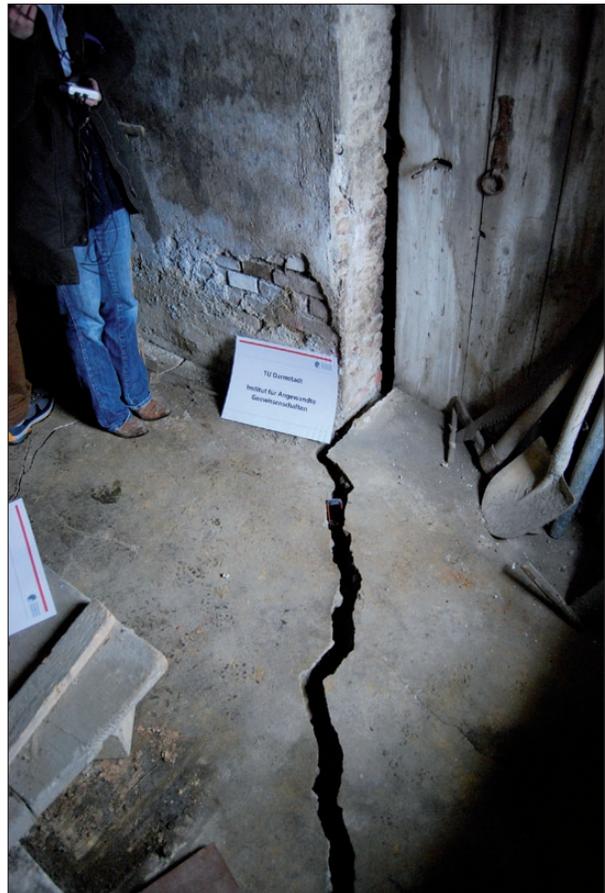
Fig. 3: Tension crack in a baseplate, building Järgergasse, distance to the well field approx. 70 m to the northeast, March 2009 (Photo: U. Burbaum).

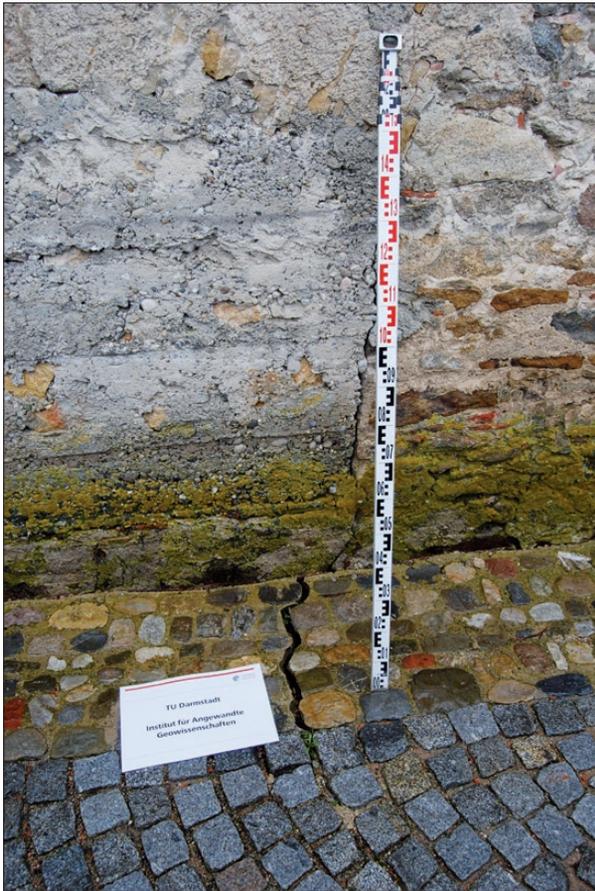
Fig. 4: Crack in the street "Jägergasse", distance to the wellfield approx. 80 m to the NE, March 2009 (Photo: U. Burbaum).

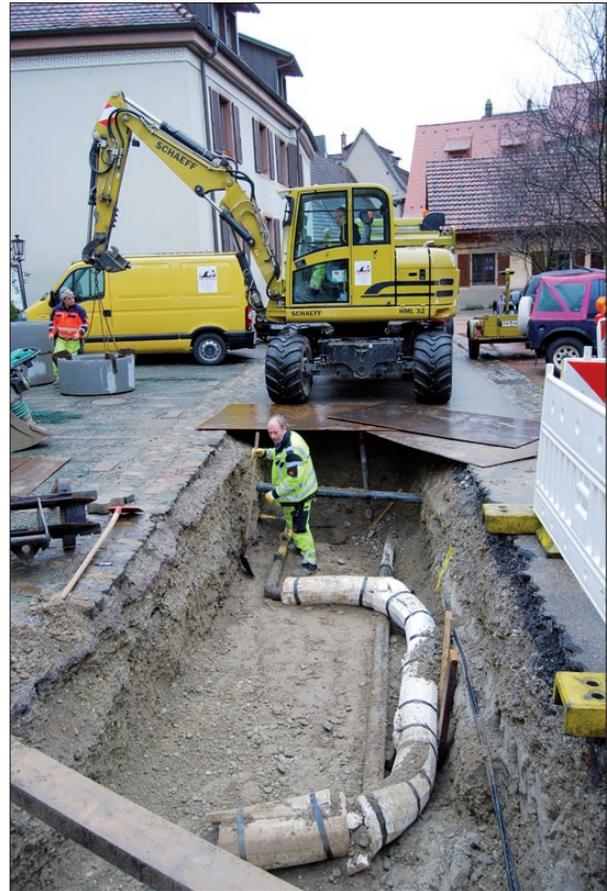
Fig. 5: Installation of an expansion bend in a PE-HD gas pipe, Meiergasse, distance to the well field approx. 80 m in northnortheast direction, March 2009 (Photo: U. Burbaum).

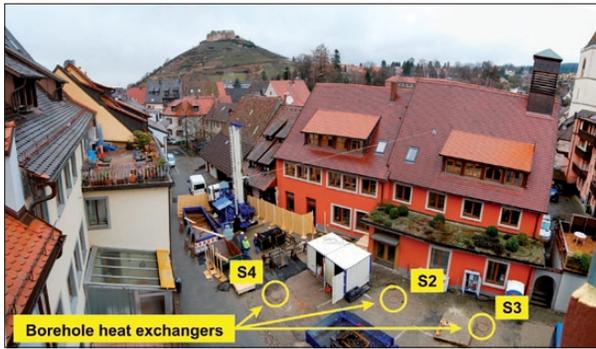
Fig. 12: Borehole heat exchanger field at Rathausgasse with drill rig for the first exploration boring for determining the cause of damage (March 2009). Photo taken from the tower of the town hall by U. Burbaum.

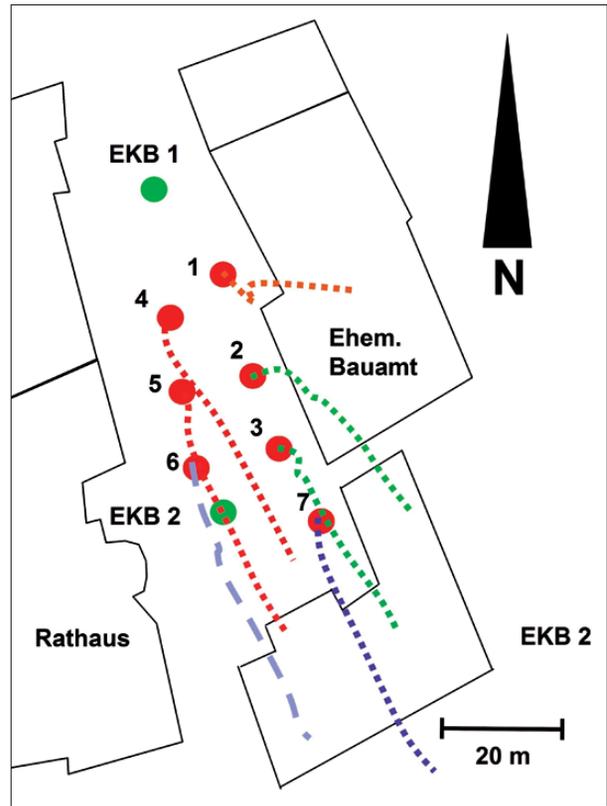
Fig. 13: Deviation of drillings.

An investigation of the inclination of the drillings shows a great horizontal deviation of all drillings up to some 20 m (LGRB 2010). This is shown in Fig. 13. The main deviation occurs in a depth of approx. 60 to 70 m. The depth correlates with the lower end of the temporary drilling casings.

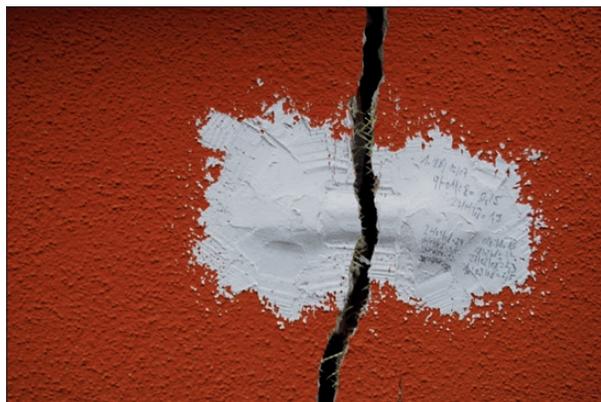
not linked to the drilling operations. From 12/2007 to 01/2008 cracks were marked with gypsum markers (Fig. 14).

Fig. 14: Gypsum markers on a crack, building Rathausgasse 3, with logs of the fracture spacing since December 2007 (Photo from March 2009 by I. Sass & U. Burbaum).

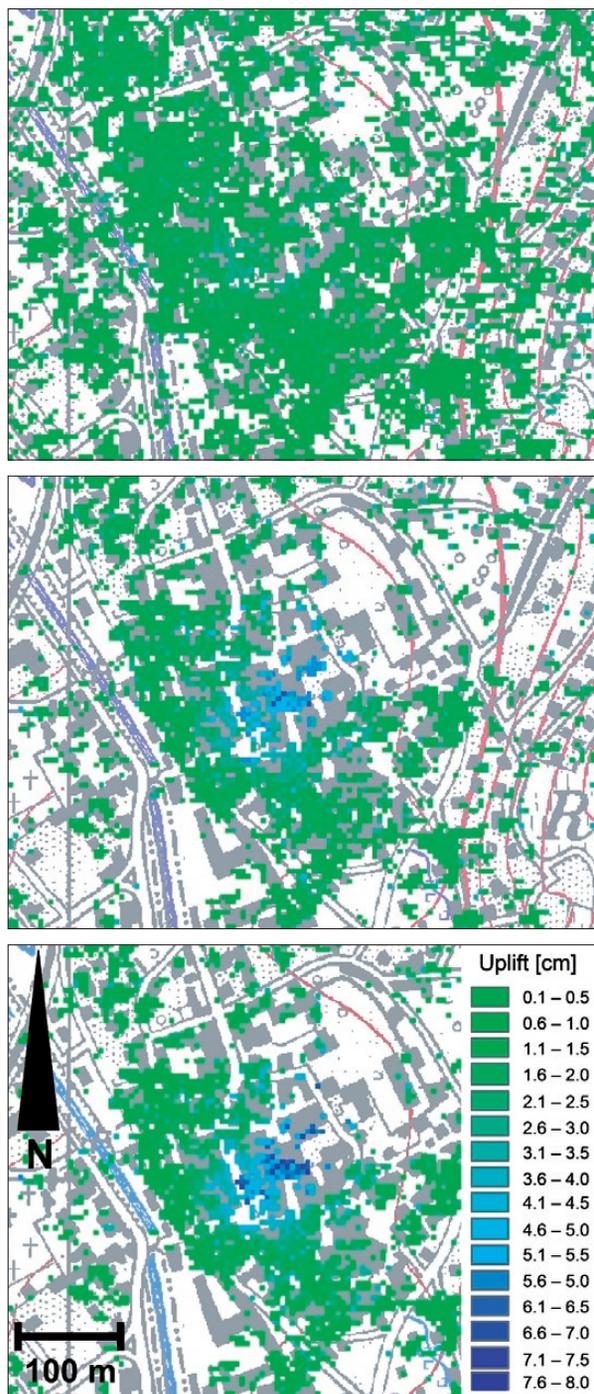
Fig. 15: Analysis of satellite-based ground level uplift monitoring by radar interferometry, a) July 2008 to 29. October 2008, b) July 2008 to 3. January 2009, c) July 2008 to 25. January 2009.

In general, results of the geodetic surveillance and satellite-based radar images (Fig. 15a-c) of the uplifted zone show an elliptical dome with a NNE-SSW axis (Fig. 16). This position coincides well with the bedding of the Jurassic, Keuper and Muschelkalk series.

2. The contour lines of the uplift are elliptical around the well field (Figs. 15 and 16), which is an indication that the contact between water and Gipskeuper is located in the centre of the ellipse.

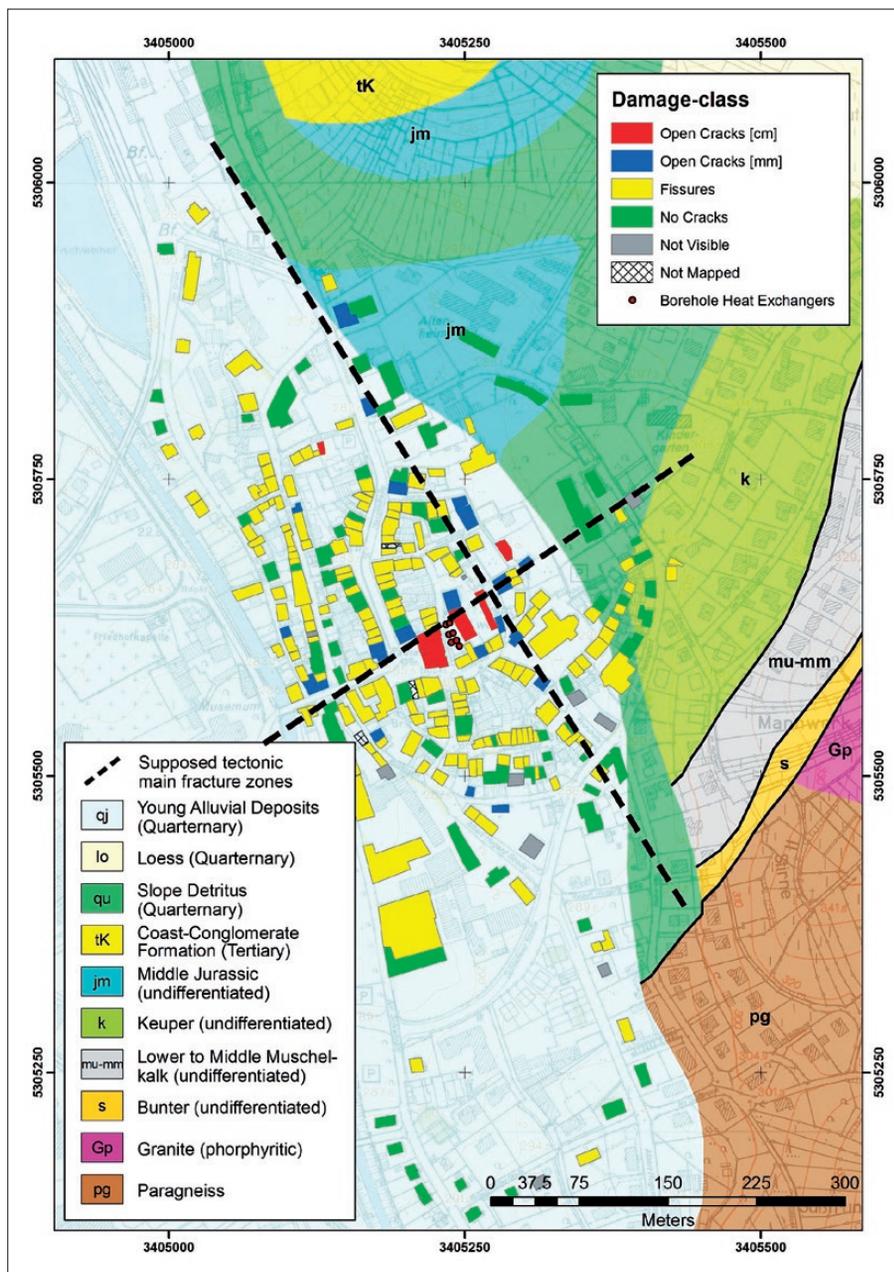
Fig. 18: Mapping of damages and geology.

per. Three very small outcrops of the Muschelkalk and the Tertiary could be investigated. Fig. 18 shows related jointing rose diagrams for the outcrop locations. The major directions can be mapped in the historic city centre of Staufen by categorizing the cracks on the outside walls of the buildings (Fig. 18).

Some buildings or parts of the buildings could not be evaluated. Most of the fissures were smaller than one millimeter. Some buildings have fissures of some millimeters width. More than four buildings have fissures of some centimeters width.

The zone of the most damaged buildings is consistent with the main orientation of geological fault structures, which is NNW-SSE and WSW-ESE (Fig. 18).

The orientation of building damages corresponds to the orientation of the discontinuities (Figs. 18 and 19) that were obtained by a field study in October 2009. It can be concluded that groundwater not only flows through drillings but now through discontinuities, too. The swelling process therefore cannot be stopped by sealing the BHE-Drillings. A larger area remediation approach must be found.
