DEGRADATION OF DOLINES ON LOGAŠKO POLJE (SLOVENIA)

Mateja Breg: Degradation of dolines on Logaško polje (Slovenia)

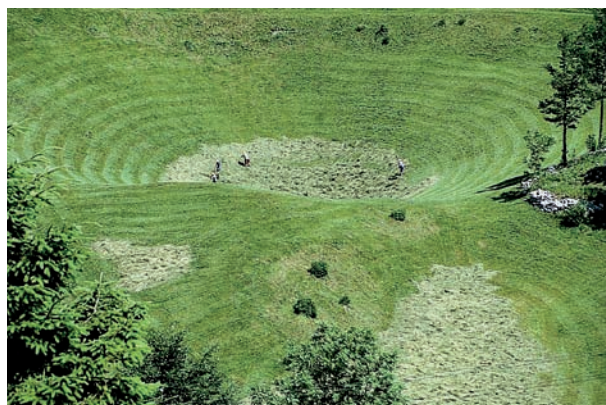
Fig. 1: Traditional meadow doline (photo by M. Gabrovec).

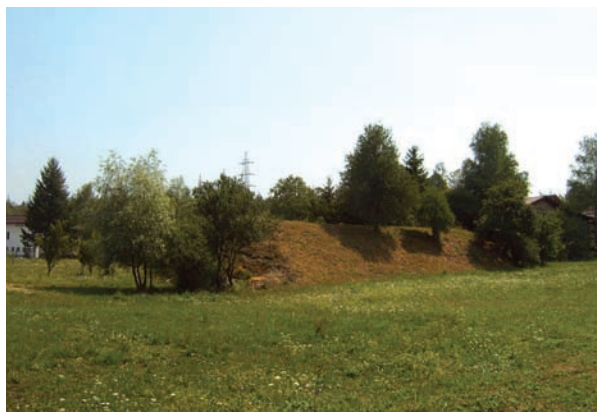
Fig. 2: The railway embankment of line Logatec – Idrija, closed after World War I (photo by M. Breg).

up with waste material from the railway embankment of the line Logatec – Idrija, close after World War I. Considering these historical facts there had probably been more dolines present in the studied area than were determined by the analysis of the aerial photograph from 1944.

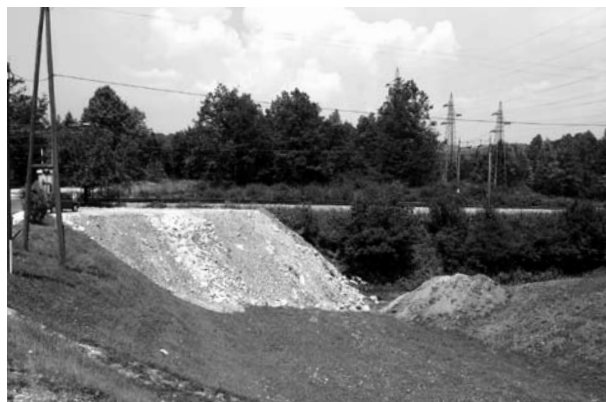
Fig. 3: Waste dump (construction and demolition waste) in the meadow-doline (photo by M. Breg).
