**MORPHOLOGICAL AND GEOLOGICAL
CHARACTERISTICS OF TWO DENUDED CAVES IN
SW SLOVENIA**

STANKA ŠEBELA¹

¹ Karst Research Institute ZRC SAZU, Titov trg 2, SI-6230 POSTOJNA, SLOVENIA

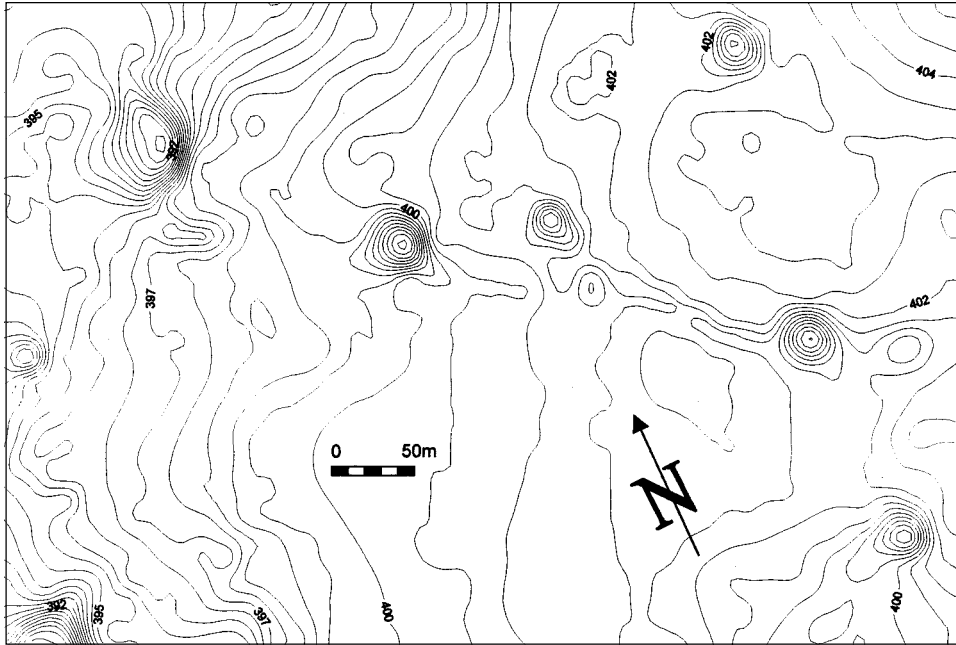
Fig. 1: Original morphology of denuded cave near Povir before construction of highway Divača-Dane. Altitudes for contour lines are in meters.

In the NW part of denuded cave a morphological depression exist as a not very typical shape of doline. Towards SE there is about 40 m of the cave passage with the roof. Than we have first about 40 m of unroofed passage which continues into the doline (bottom on 395,9 m). The doline was 10 m deep with 40 m of diameter. From the doline towards SE there is unroofed passage which runs out from the highway and continues through the doline south from the highway.

The cave is well visible also on aerial photographs as white zone what represents different vegetation due to thicker sediments. In the south corner of Fig. 1 the cave passage was determined from aerial photographs, even before it was proved on the field. In the cave history both passages probably belonged to the same cave system.

Denudirana jama pri Povirju (na trasi Divača-Dane) je 320 m dolg in do 10 m širok rov, kjer ponekod lahko še najdemo jamski strop, čeprav prevladuje rov brez stropa. Na topografski karti v merilu 1:1.000, kjer so izohipse na 1 m ali celo na 0,5 m, je morfologija denudirane jame zelo dobro vidna (slika 1). Na sliki 2 je bil denudiran rov v južnem robu slike določen po opazovanju letalskih posnetkov. Denudirana jama pri Povirju je razvita v liburnijski formaciji, K-Pc (Jurkovšek et al. 1996). Plasti apnenca vpadajo proti jugu in jugozahodu za 20-30°. Denudirana jama pri Povirju leži okrog 200 m severno od Divaškega preloma (slika 3).

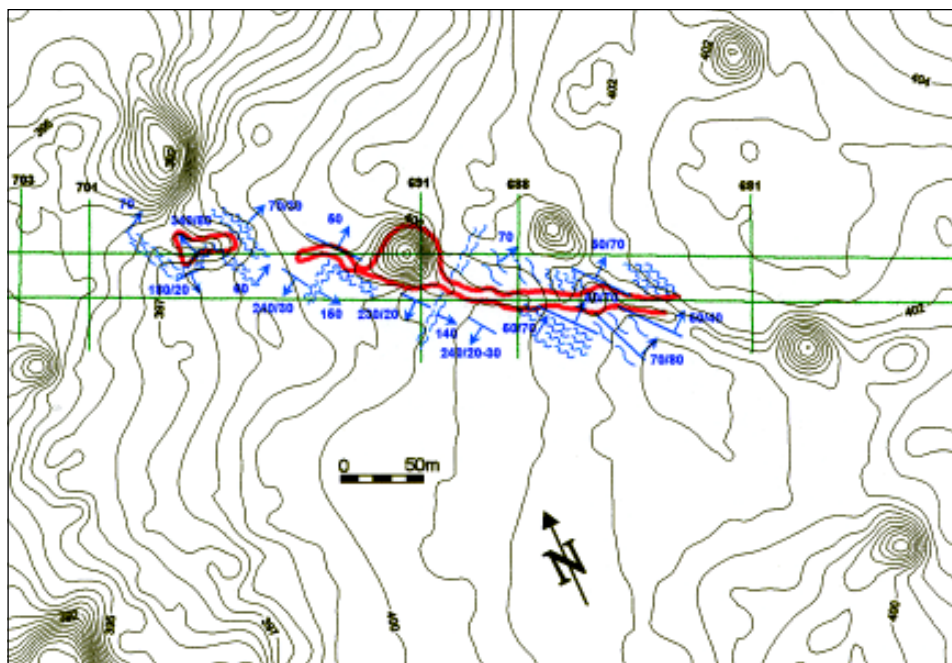
Fig. 2: Geological map of denuded cave near Povir.

1-denuded cave, 2-denuded cave determined from aerial photographs, 3-strike and dip of limestone bedding planes, 4-fault, 5-fissured zone, 6-broken zone.

In NW part of the cave the limestone dips towards S for 20°, in central and SE part limestone dips towards SW for 20-30° (Fig. 2). The thickness of the limestone beds is 0,2-0,4 m. According to geological map of Jurkovšek et al. (1996) between denuded cave and Divača fault a syncline is situated in general direction NW-SE. It dies out just in the area between the cave and Divača fault (Fig. 3). According to geological measurements in the cave we can confirm that idea.

The denuded cave near Povir is situated about 200 m north from Divača fault (NW-SE direction). In the cave the fault 50/70-90° is well expressed from central to E part of the cave. We can also follow the fractured zones 70/80°, 150° and 140°. In the western doline fractured zones 70/30°, 70°, 60° and 340/80° are present.

The cave passage is mostly developed according to direction of bedding planes.

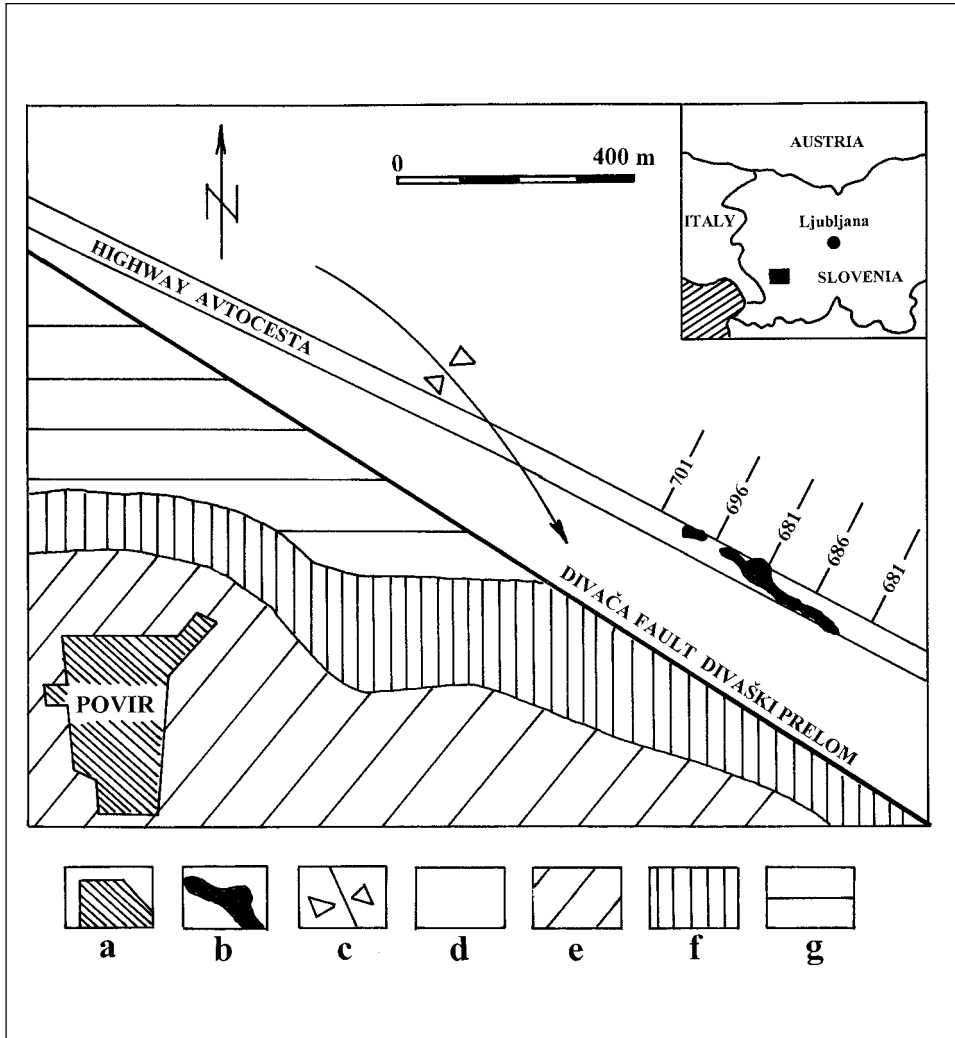
Fig. 3: Geological map of wider area around denuded cave near Povir.

a-village, b-denuded cave, c-syncline, d-Liburnian Formation (K-Pc), Bedded and platy limestone, marly limestone and limestone breccia, e-Bituminous granular dolomite, Povir Formation ($K_{1,2}$), f-dolomitic breccia, Povir Formation ($K_{1,2}$), g-alteration of limestone, dolomite, limestone and dolomitic breccias, Povir Formation ($K_{1,2}$).

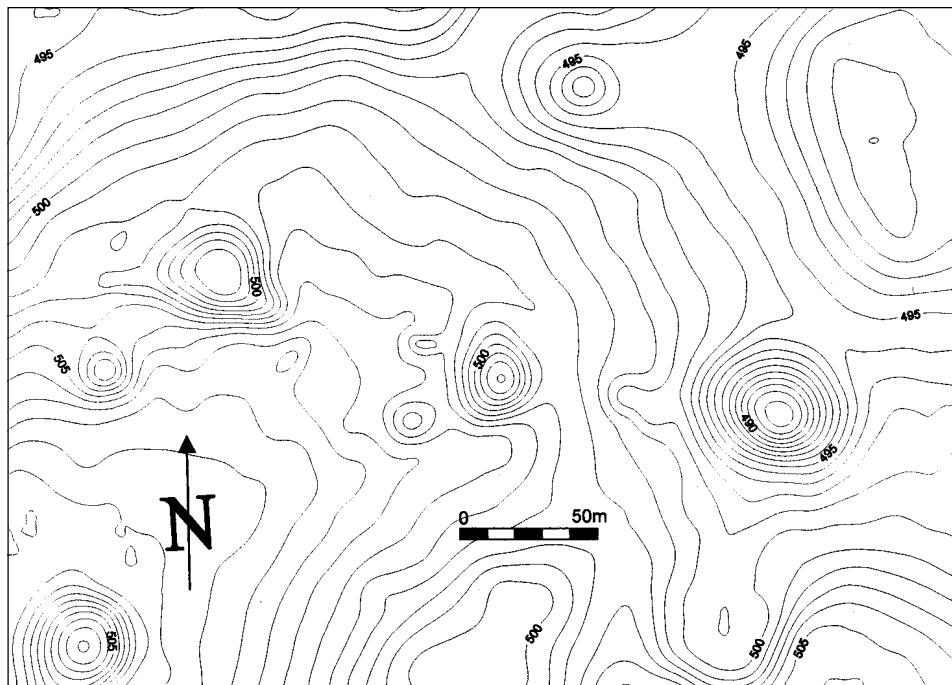
Fig. 4: Original morphology of denuded cave near Kačiče-Pared before construction of highway Divača-Kozina. Altitudes for contour lines are in meters.

The cave between cross section 139 and 149 on the highway was very good morphologically expressed even before highway construction (Fig. 4). All together about 80 m of the cave passage was determined. General direction of the cave is E-W to NW-SE. In the W part unroofed cave was morphologically deepened for 0,5-1 m in original topography. After about 30 m cave passage was lost in the doline (bottom of the doline 497,2 m) which was probably former cave chamber. The continuation of the cave towards E is not well determined. We think that the cave has still the roof in that part. The unroofed cave was possible to follow about 20 m E from the old road Divača-Kozina what is also well seen from the morphology on the topographic map (1:1.000).

The cave is situated between 497,2-505 m a.s.l. It's filled with cave sediments. In 80 m long cave passage about 20 m still has the roof.

Na trasi avtoceste Divača-Kozina smo s predhodnimi krasoslovnimi raziskavami določili 4 jame brez stropa (Šebela 1996), kasneje so ob gradnji odkrili še 2 taki jami. Morfološko je bila izredno dobro izražena denudirana jama (slika 4) pri kraju Kačiče-Pared (slika 5). Jama je razvita v alveolinsko-numulitnem apnencu (eocen), ki vpada proti SV za 10-30° (slika 6). Glede na regionalno geologijo leži denudirana jama pri kraju Kačiče-Pared v južnem krilu sinklinale (slika 5).

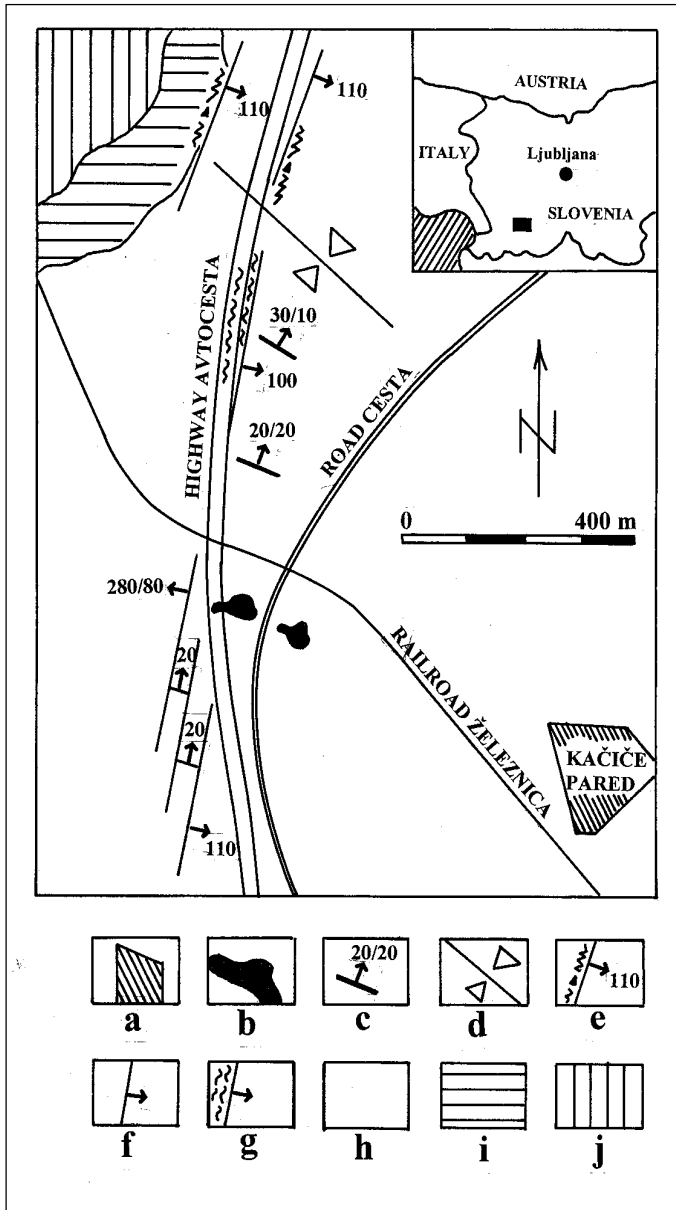
Fig. 5: Geological map of wider area around denuded cave near Kačiče-Pared. a-town, b-denuded cave, c-strike and dip of bedding planes, d-syncline, e-fault zone, f-fault, g-broken zone, h-alveolinid-numulitid limestone, Eocene, i-operculina limestone, Eocene, j-Slivje limestone, Upper Paleocene.

The cave is developed in Eocene limestone (Jurkovšek et al. 1997) in SW part of the syncline which runs in Dinaric direction (NW-SE) North from Kačiče-Pared (Fig. 5). Alveolinid-numulitid limestone dips towards NE for 10-30° (Fig. 6). It's bedded; locally limestone with chert and limestone with lithothamnians, corals and hydrozoans (Jurkovšek et al. 1996). The direction of the principal fissured to broken zones is 290/70° or 110° (Fig. 6). The fissures in the direction 40° and 190/80° are also present.

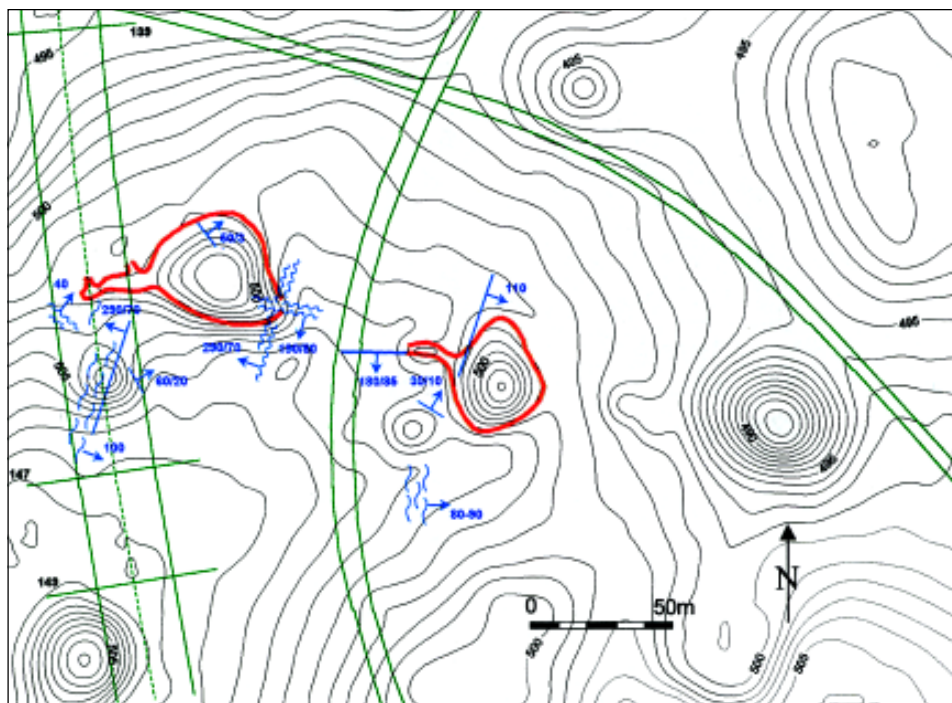
Fig. 6: Geological map of denuded cave near Kačiče-Pared.

1-denuded cave, 2-strike and dip of limestone bedding planes, 3-fault, 4-fissured zone, 5-broken zone.
