DAMAGE TO THE HISTORIC TOWN OF STAUFEN (GERMANY) CAUSED BY GEOTHERMAL DRILLINGS THROUGH ANHYDRITE-BEARING FORMATIONS

Ingo SASS¹ & Ulrich BURBAUM²

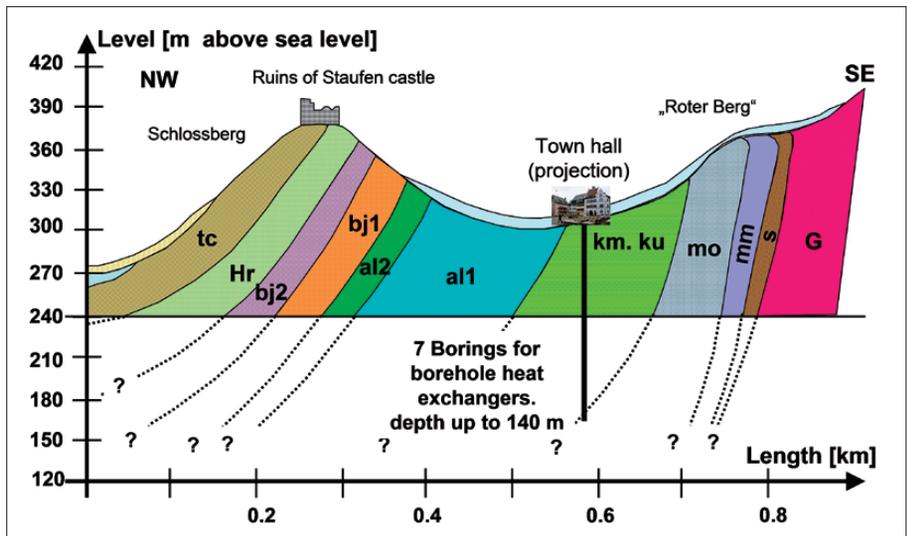
Fig. 7: Geological cross section NW-SE (modified after Schreiner, A. 1991, cited in: Landesanstalt für Umweltschutz Baden-Württemberg 2005).

vermessungsamt Baden-Württemberg 1996; LGRB 1977; Wagenplast 2005). The aquifers in the Muschelkalk have, due to their location and their catchment areas on the higher ground in the outlying hills, the potential to be artesian in the inner city districts of Staufen (Fig. 7).

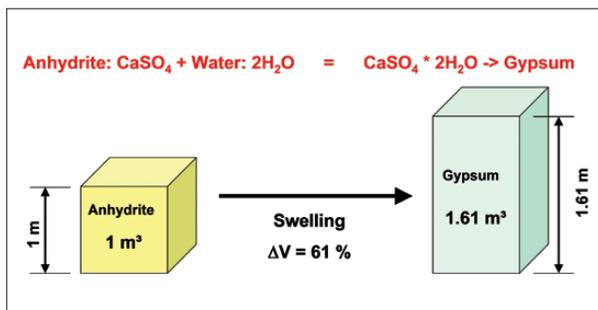
Fig. 8: Swelling process of anhydrite into gypsum.

ing in the formation, with an increase of volume up to 60% (Fig. 8). Swelling processes in anhydrite have been described often (Chiesi *et al.* 2010; Steiner 1989, 1993, 2007). If swelling is prevented due to confining conditions, immense swelling pressures may occur. In some tunnel projects in anhydrite rock, swelling pressures from 1.7 up to 4.7 MPa were monitored (Steiner 1989, 1993, 2007). Swelling could be avoided only if sufficient overburden rock mass is present. The relationship between necessary

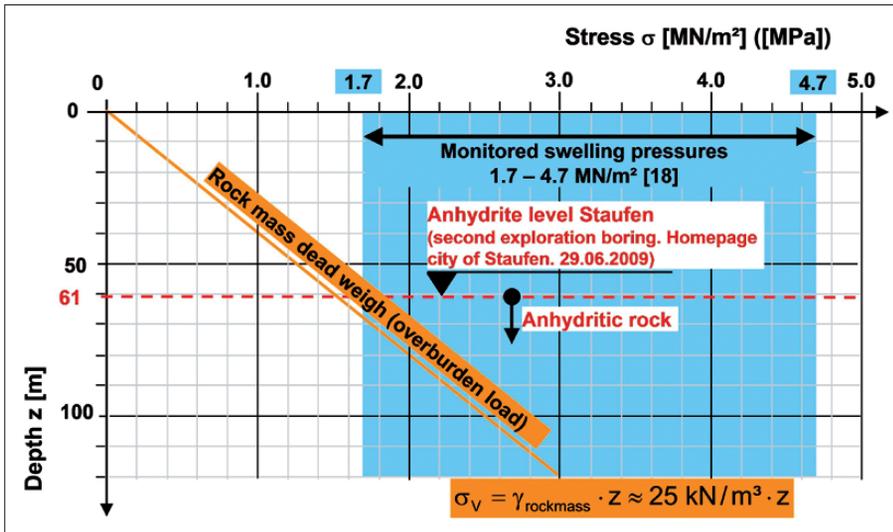
Fig. 9: Swelling pressure (modified from Steiner 1989, 1993, 2007).

overburden rock mass and possible swelling pressure is shown in Fig. 9. The dead weight of rock mass related to its depth is compared to the swelling pressure monitored by Steiner (Steiner 1989, 1993, 2007). The anhydrite rock in Staufen is located at about 60 m depth (see below). Thus, the overburden rock mass is insufficient to prevent swelling.

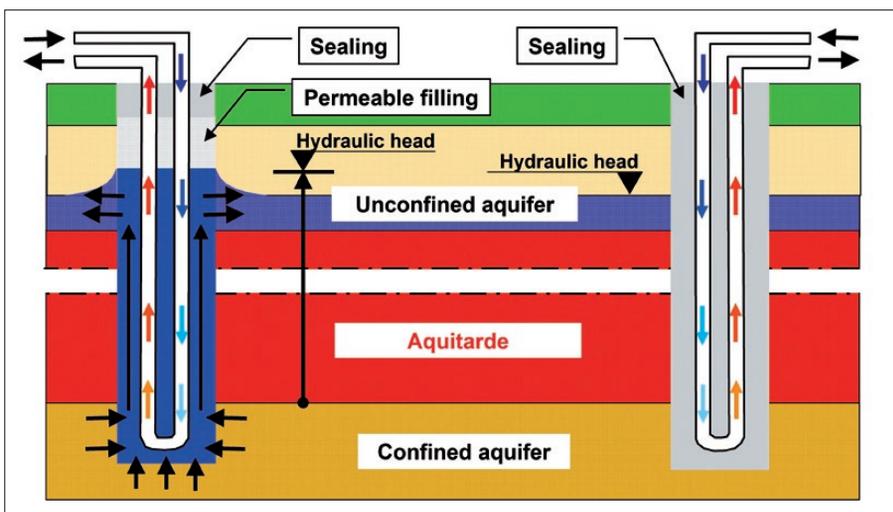
systems, Fig. 10, left side). If groundwater is present, it is thermally most efficient to use no backfill. However, regulations in Germany require a complete grouting of the annular space.

Fig. 10: Filling of borings for borehole heat exchangers.

Left: Unsealed BHE, Right: Sealed BHE

groundwater resources. Using ungrouted BHE systems, heat exchanger fluids (if they contain antifreeze agents like monoethyleneglycol) may contaminate groundwater in case of a leakage from the pipes. Furthermore, layered aquifers are kept from communicating with each other. Additionally, surface contaminants may infiltrate downward into groundwater resources in unsealed BHE systems.

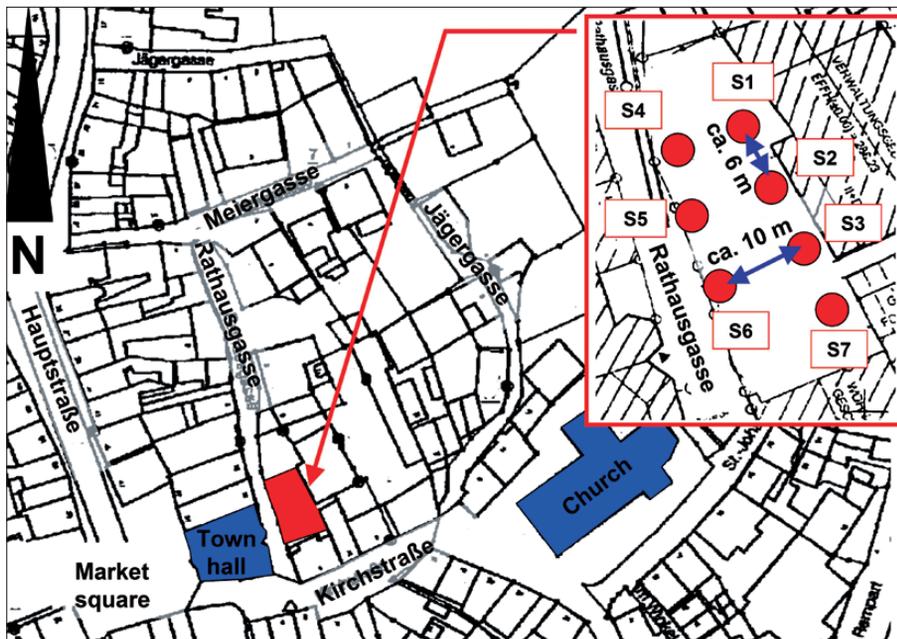
Well S1 reportedly penetrated artesian groundwater at a depth of 32 m. The piezometric level at the wellhead was at about 0.5 m above ground surface (Report 2007b). All other wells did not encounter artesian conditions (according to residents and the administration of Staufen). It can be concluded that the hydraulic potential of the Muschelkalk karst aquifer was connected

Fig. 11: Site sketch of well locations with interspaces at the city of Staufen town centre.

to the borehole S1 via fractures penetrating the Lettenkeuper layers. However, drilling contractor well logs show artesian conditions in all wells. Information on artesian control during drilling operations are missing in the well logs.

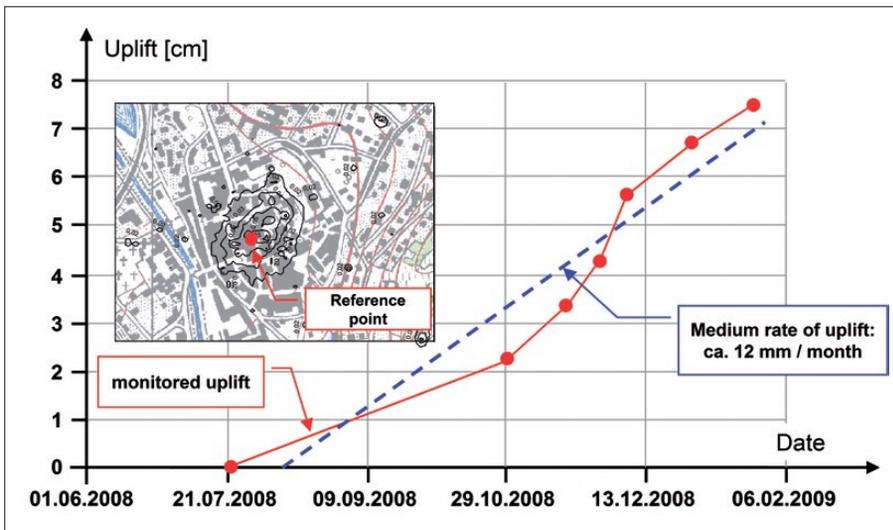
in vegetation on the surface. Longer time ranges cause higher losses. The movement information was interpolated to achieve a better interpretation. Interpolations were used to calculate contour lines, which have been plotted over the available uplift results (Fig. 16). The time-uplift relationship for a selected location is plotted in Fig. 17. The calculated uplift rate is approx. 12 mm per month. This value correlates well with the geodetic leveling measurements (Schad 2008).

Fig. 17: Chronological development of the uplift of the town centre.

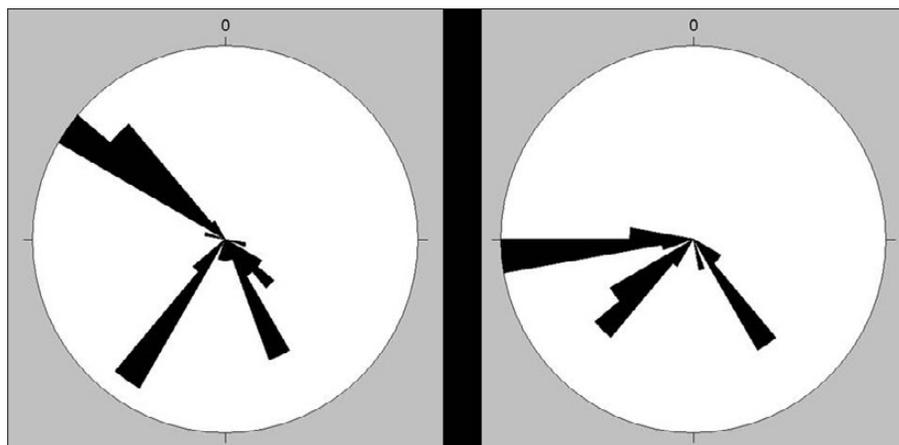
The orientation of building damages corresponds to the orientation of the discontinuities (Figs. 18 and 19) that were obtained by a field study in October 2009. It can be concluded that groundwater not only flows through drillings but now through discontinuities, too. The swelling process therefore cannot be stopped by sealing the BHE-Drillings. A larger area remediation approach must be found.

Fig. 19: Rose diagrams of outcrops.
Left: Upper Muschelkalk, Right:
Hauptrogenstein.
